## Repair of Terrazzo stairs crackings facing

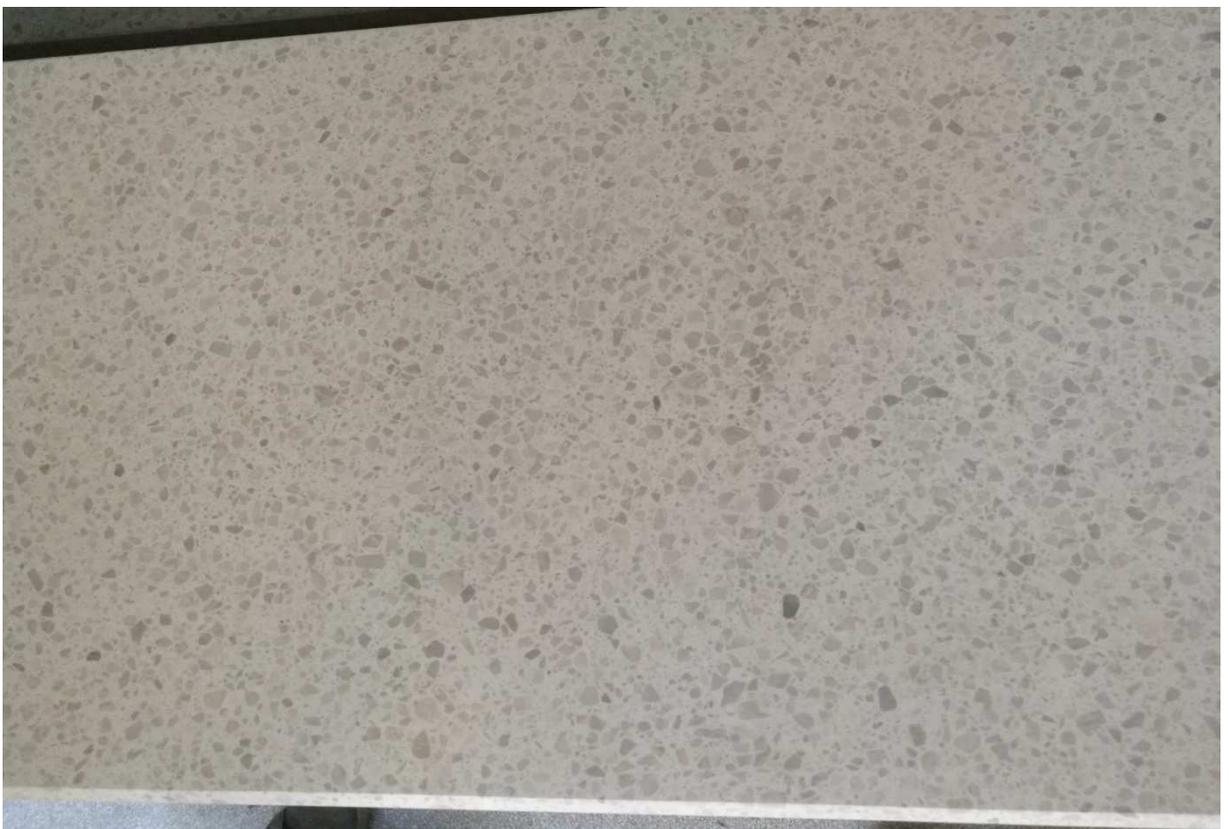
Terrazzo element before cracking

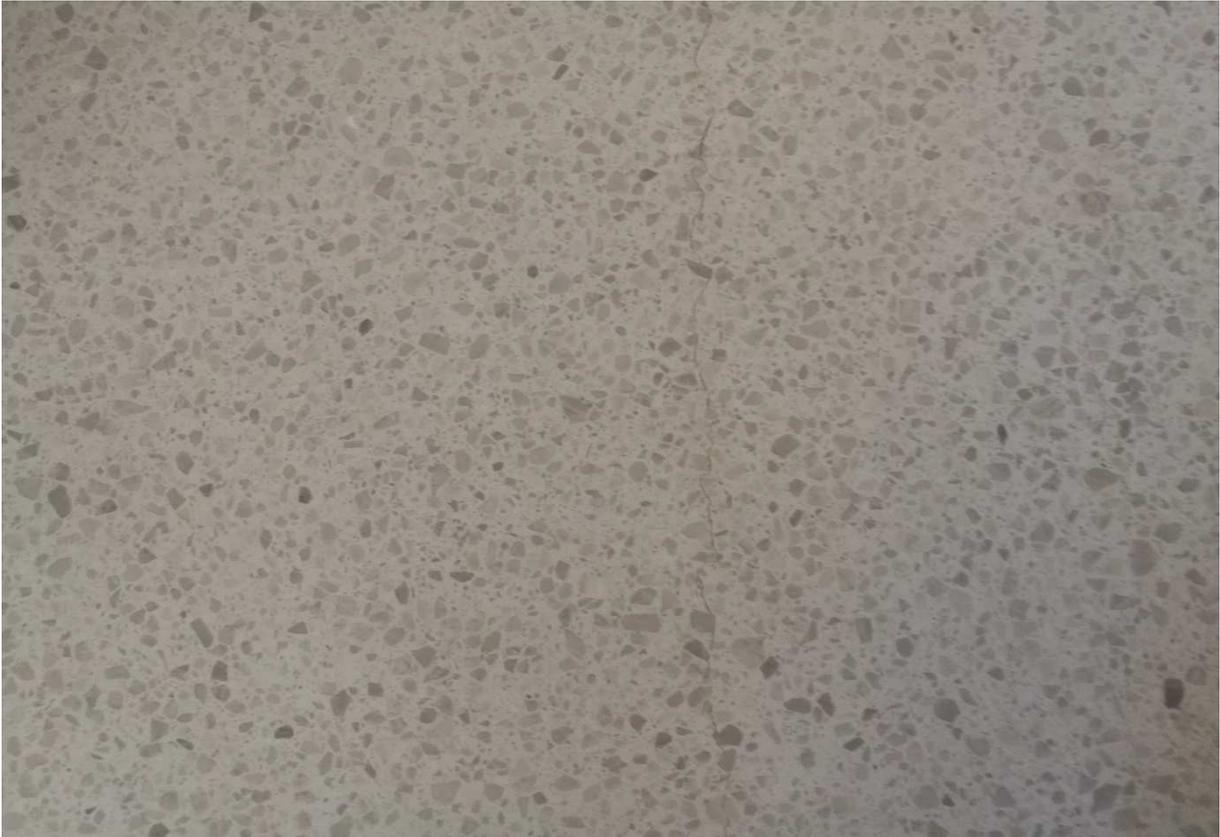
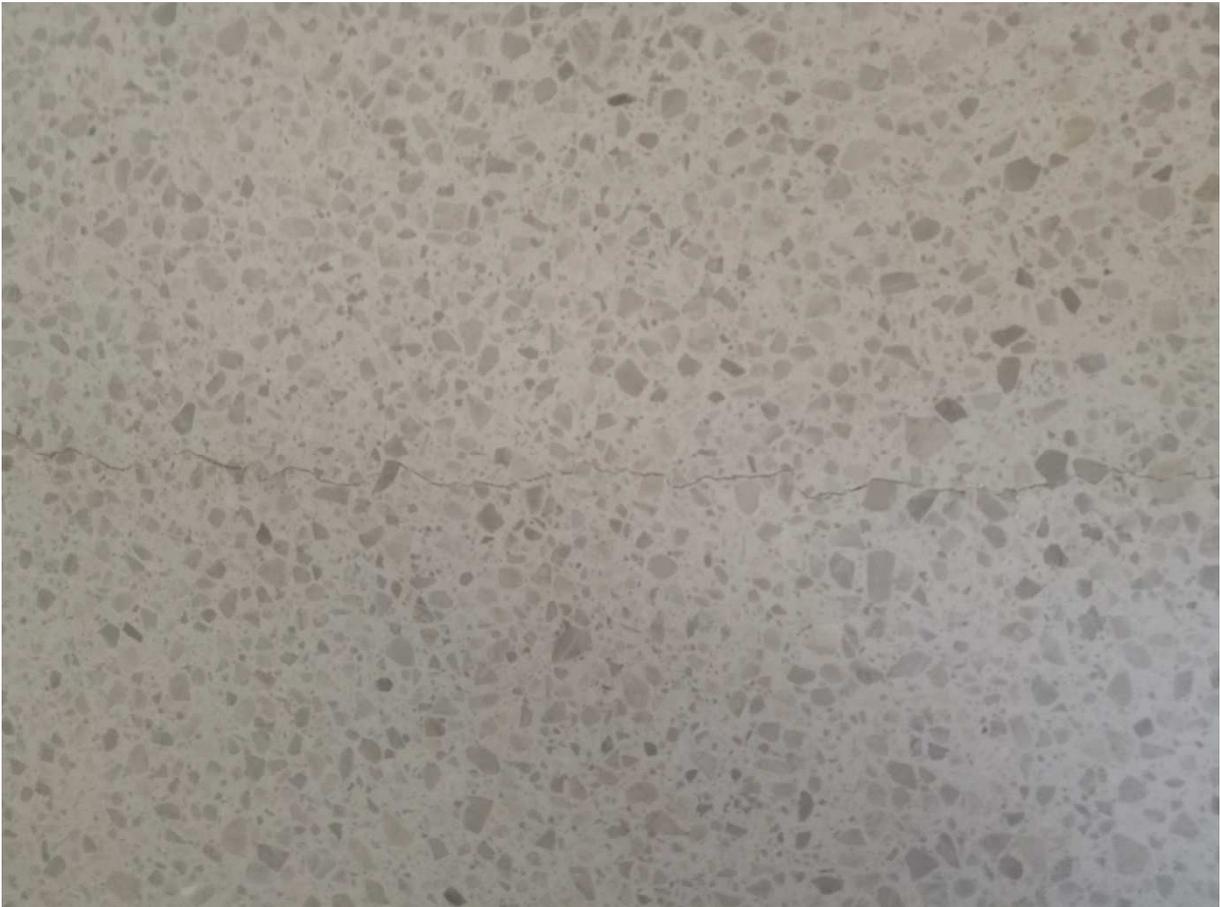
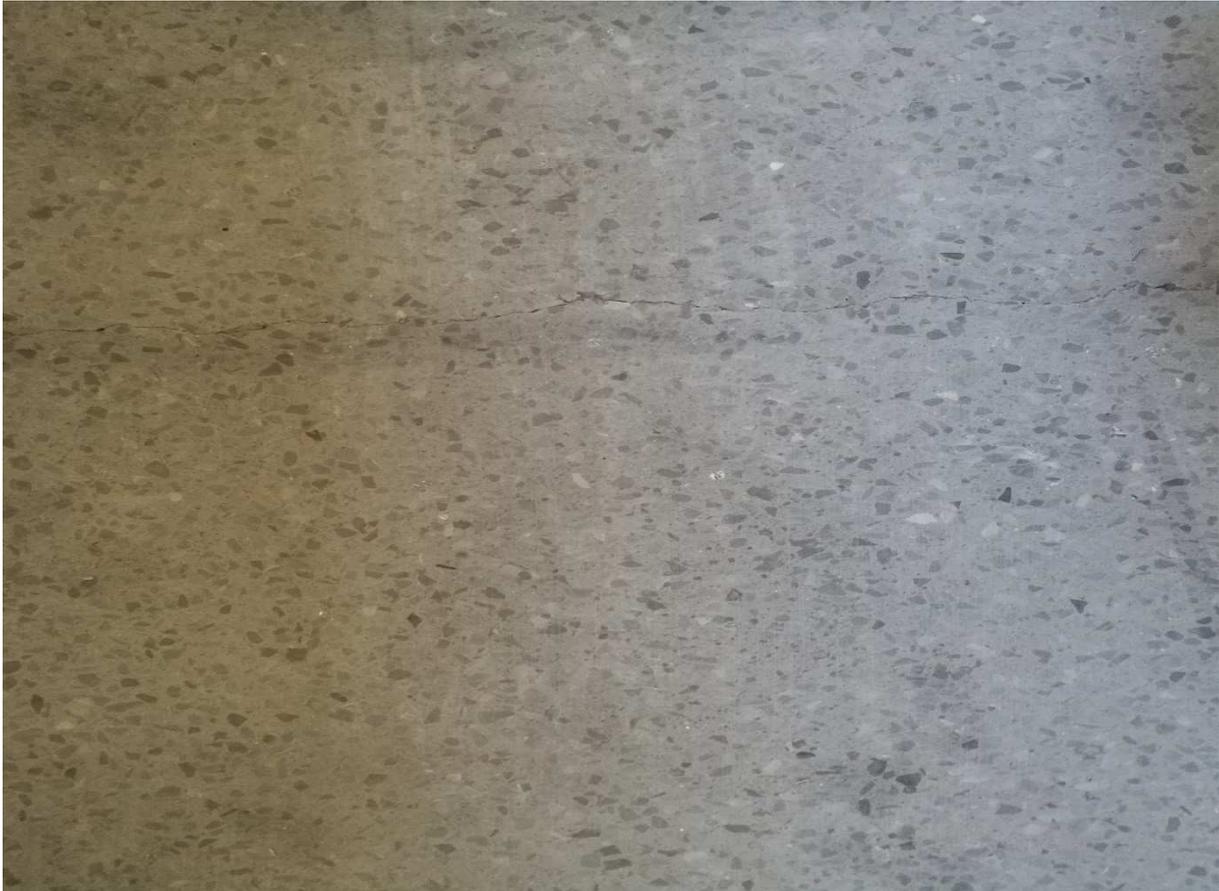
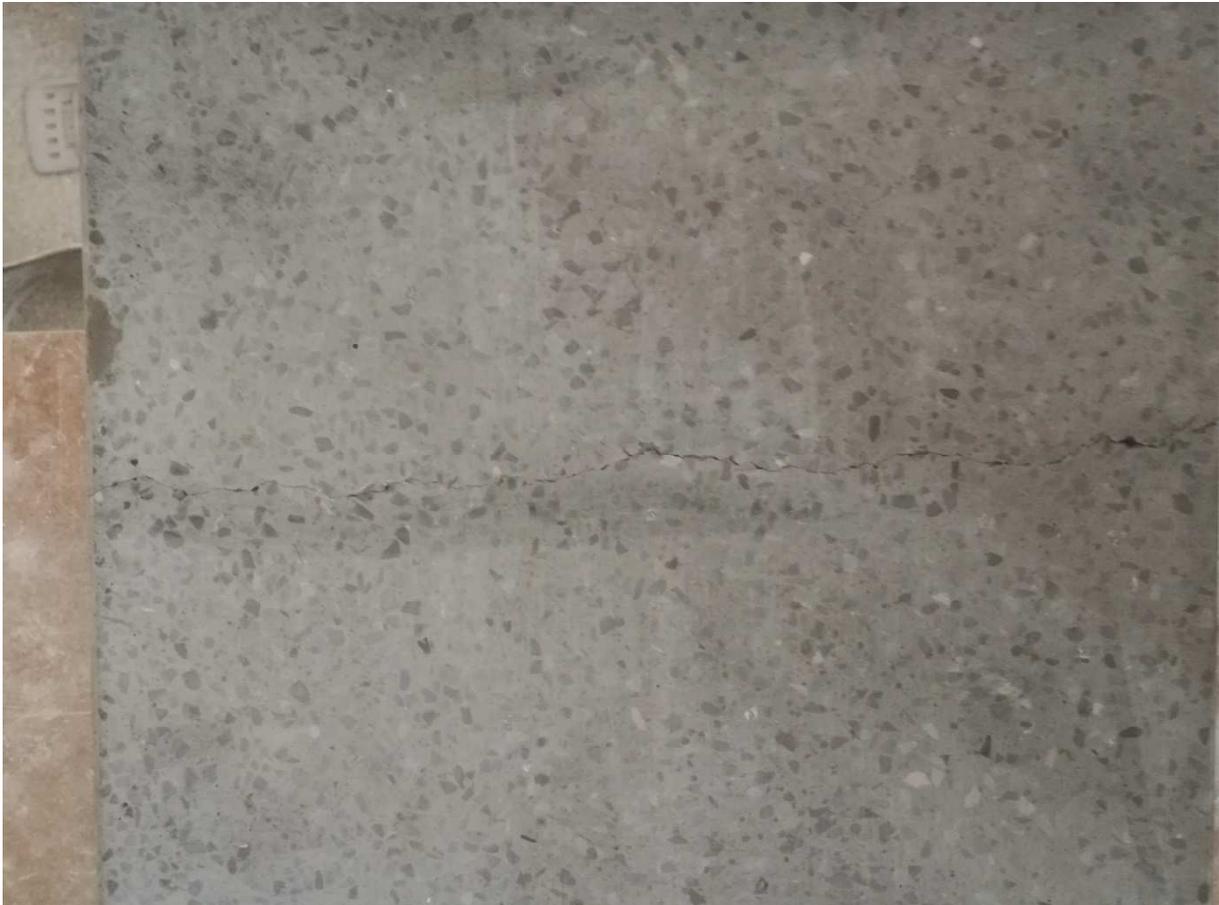
One of the elements where the movement is visibly manifested is the cladding of the stairs where a transverse crack occurs on the surface. This crack is not a crack limiting strength, but in most cases it is a surface crack that extends to a maximum depth of about 5mm, and does not even affect the inner metal reinforcement. It is this crack that is a reflection of the movement on the construction site, and movement beyond the surface cannot be displayed.

1. **Terrazzo crack** - on a white terrazzo cladding, we have created a similar crack to that found on construction sites. We also include a black terrazzo element with a crack.

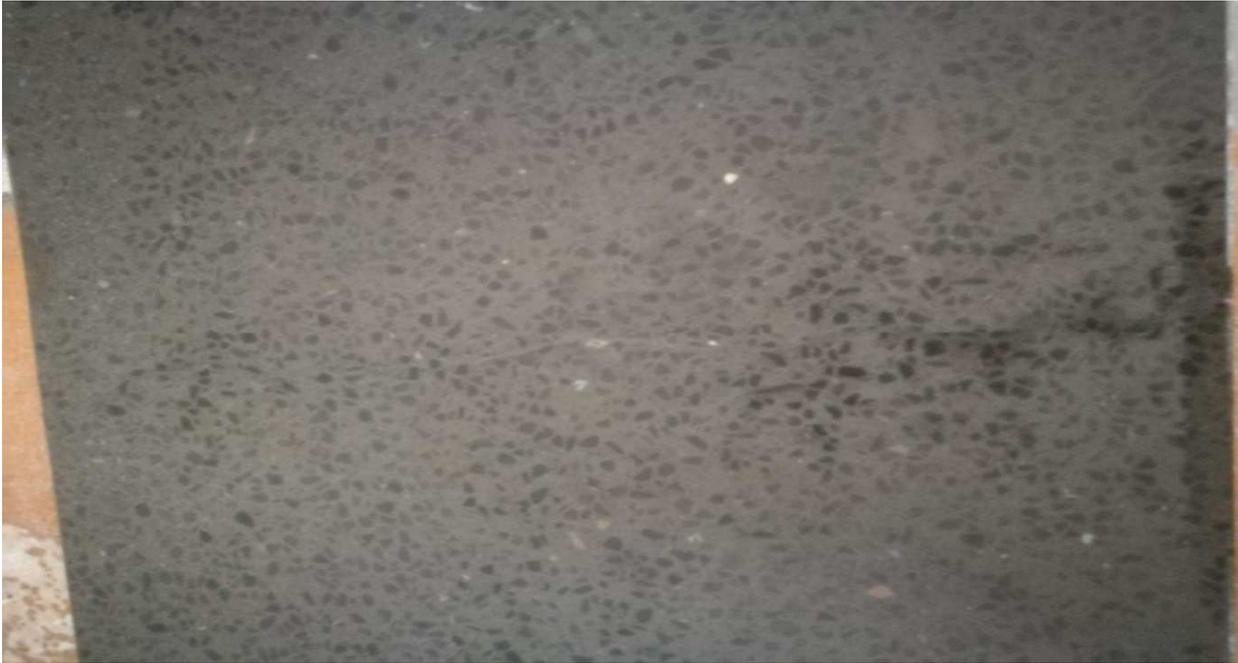
Photo of the repaired joint in the black terrazzo immediately after repair

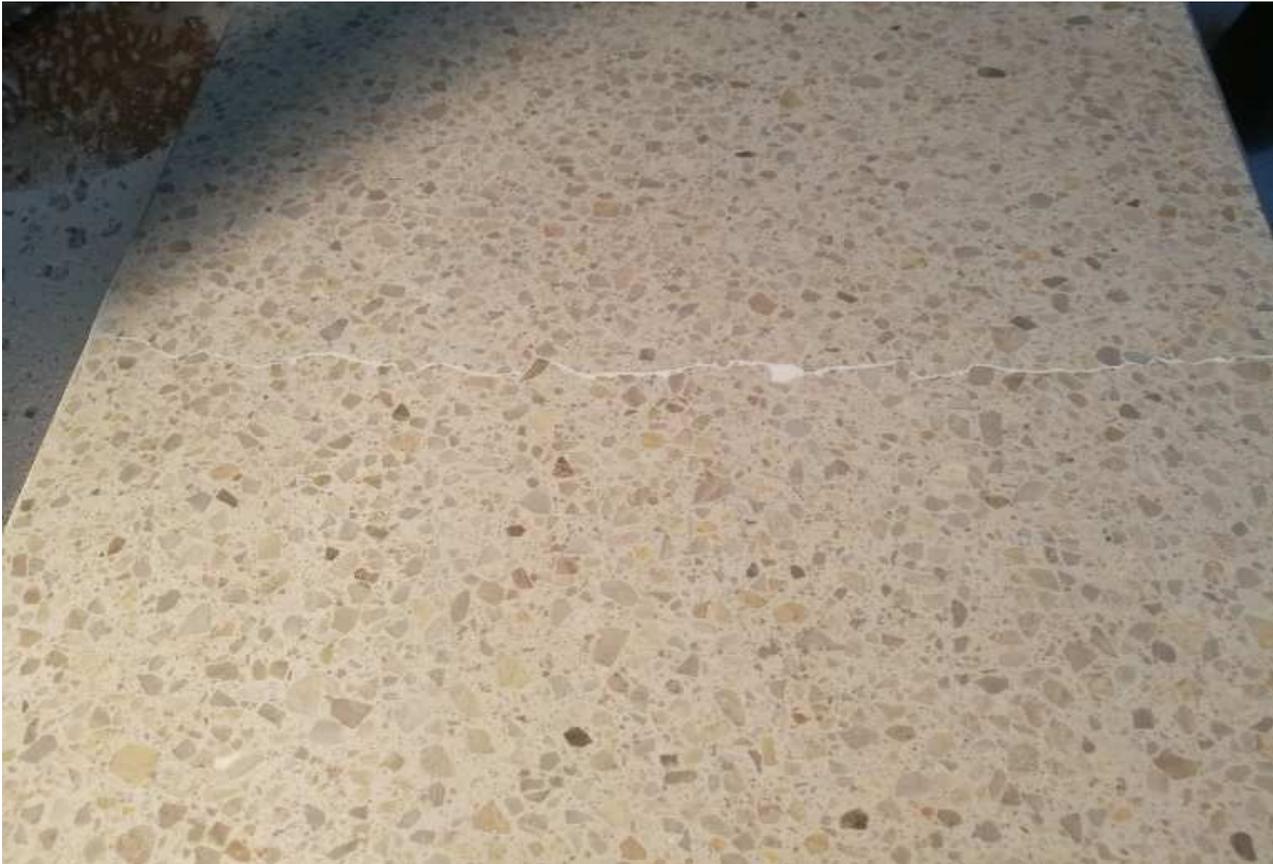
Photo of repaired joints in the terrace immediately after repair - wet surface

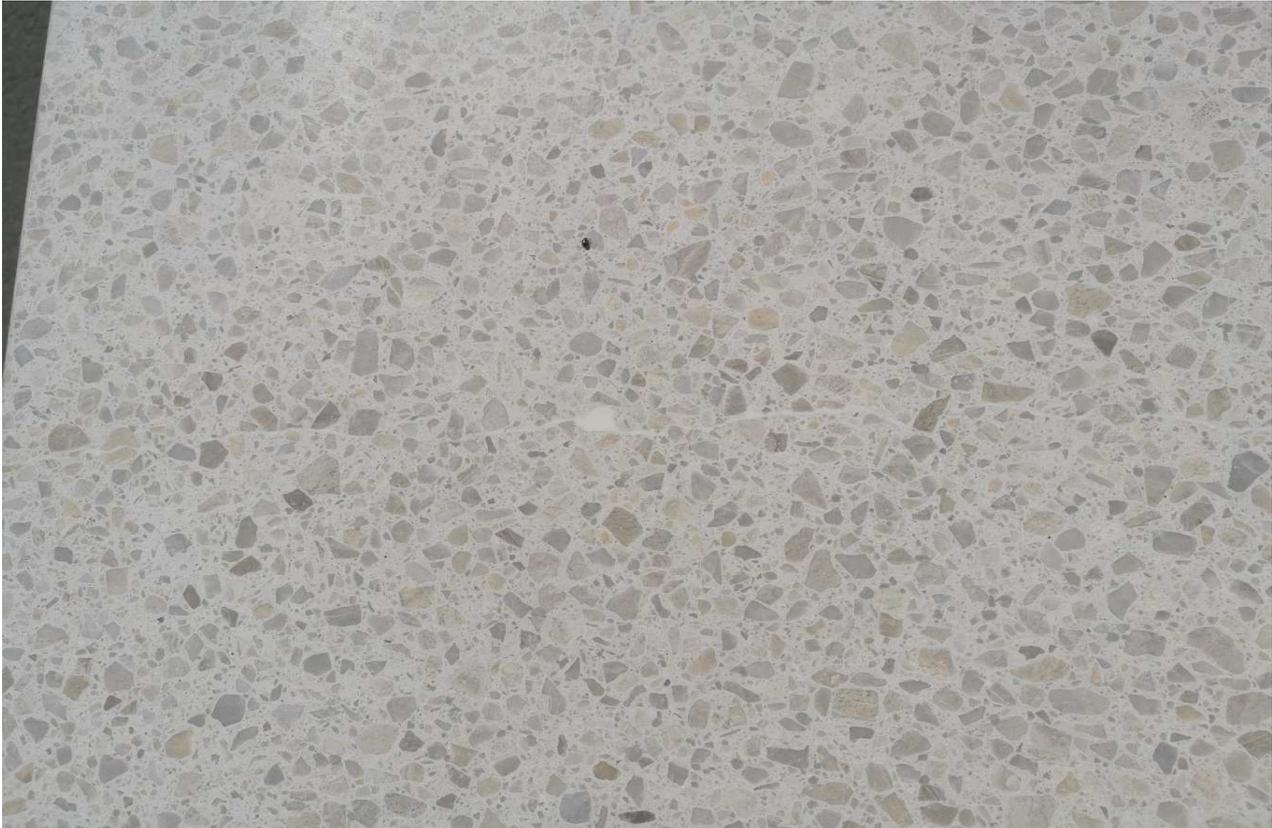
Photo repaired cracks - white terrazzo - the next day, photo close up - about 20cm

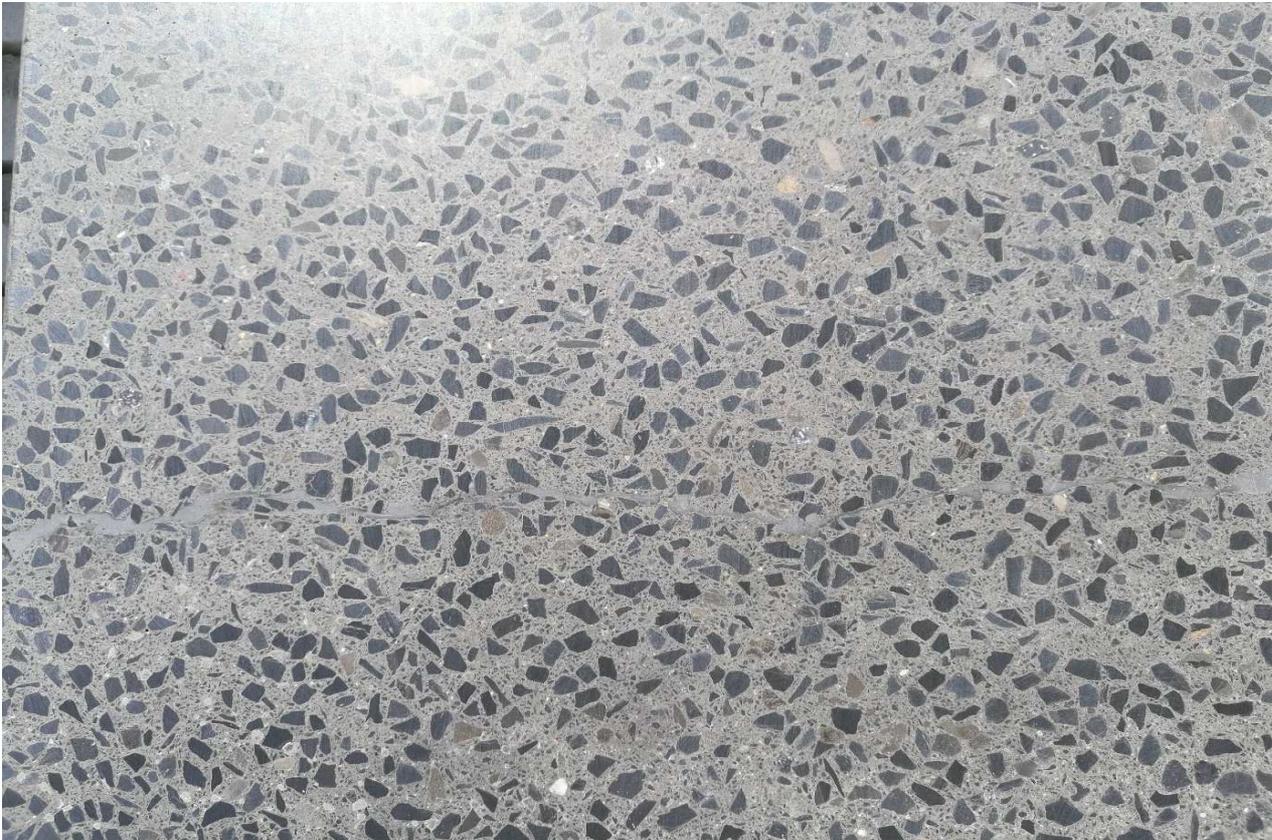
Photo repaired cracks - black terrazzo - the next day, close up - about 20cm

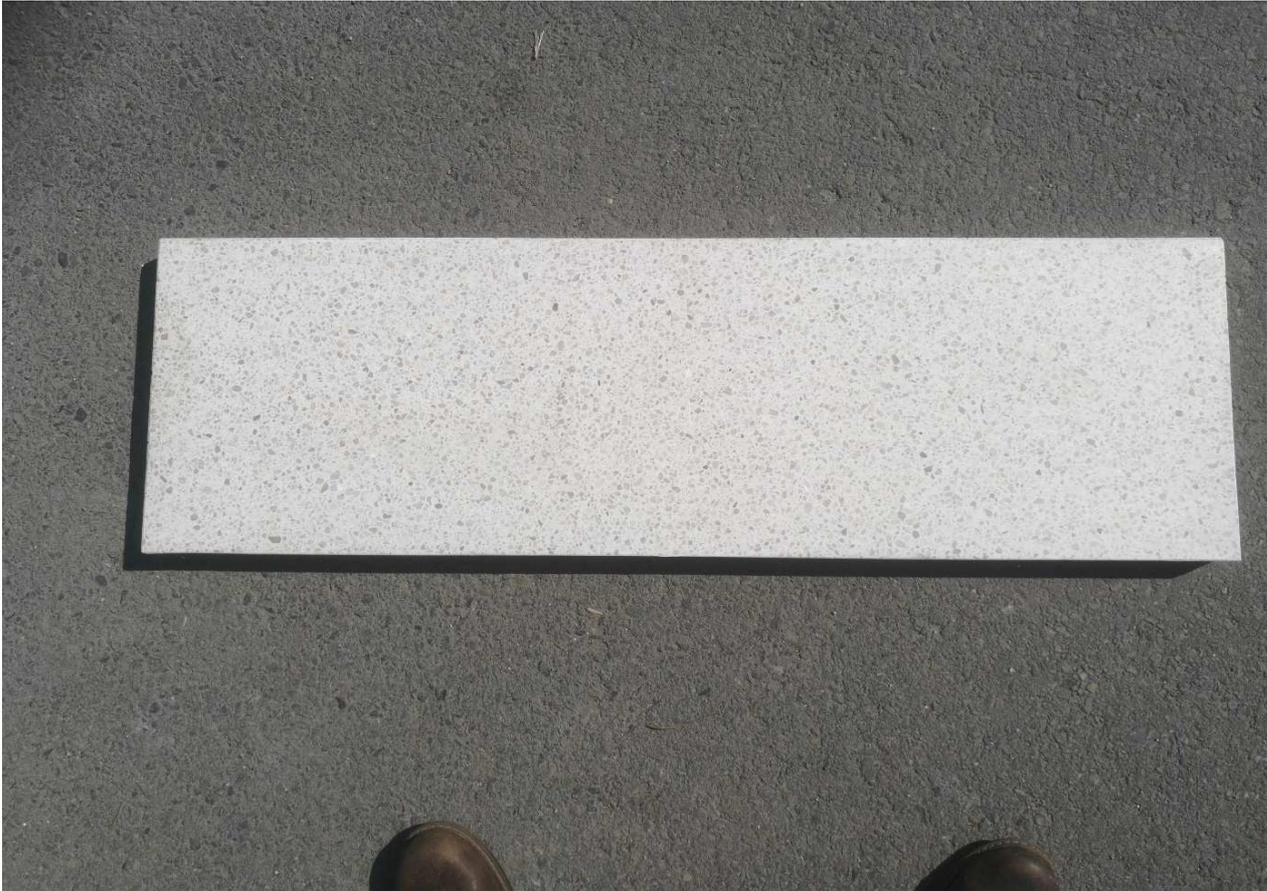
Photo repaired cracks - white terrazzo - the next day, photo from a height of about 1.0 - 1.2m

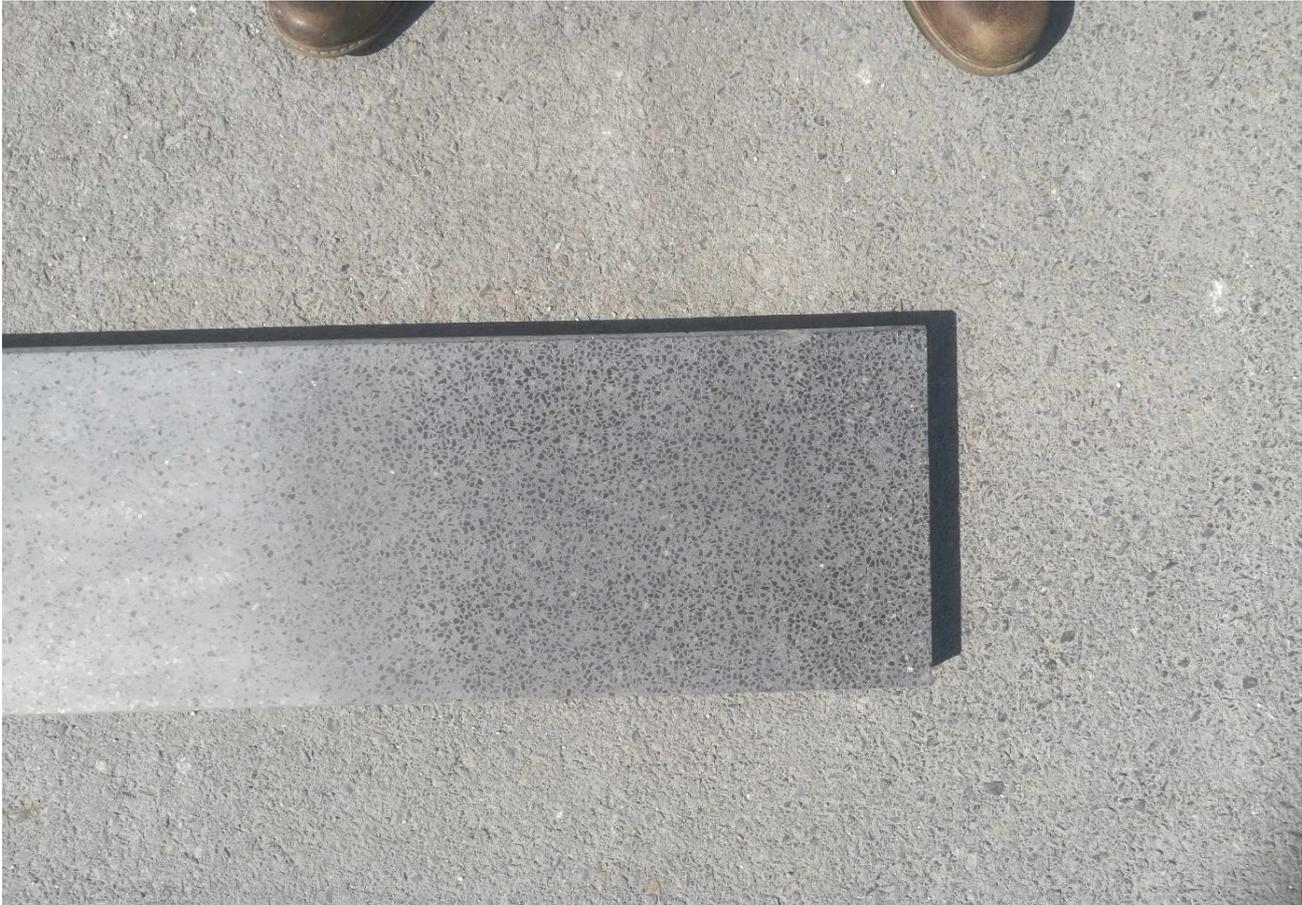
Photo repaired cracks - black terrazzo - the next day, photo from a height of about 1.0 - 1.2m
